**REPORT NO. 01-16**

**M871A3 TACTICAL TRAILER**  
**22.5-TON PAYLOAD CAPACITY**  
**TP-94-01,**  
**“TRANSPORTABILITY TESTING PROCEDURES”**

**M871 Tactical Trailer, 22.5-Ton Payload Capacity  
TP-94-01, "Transportability Testing Procedures"**

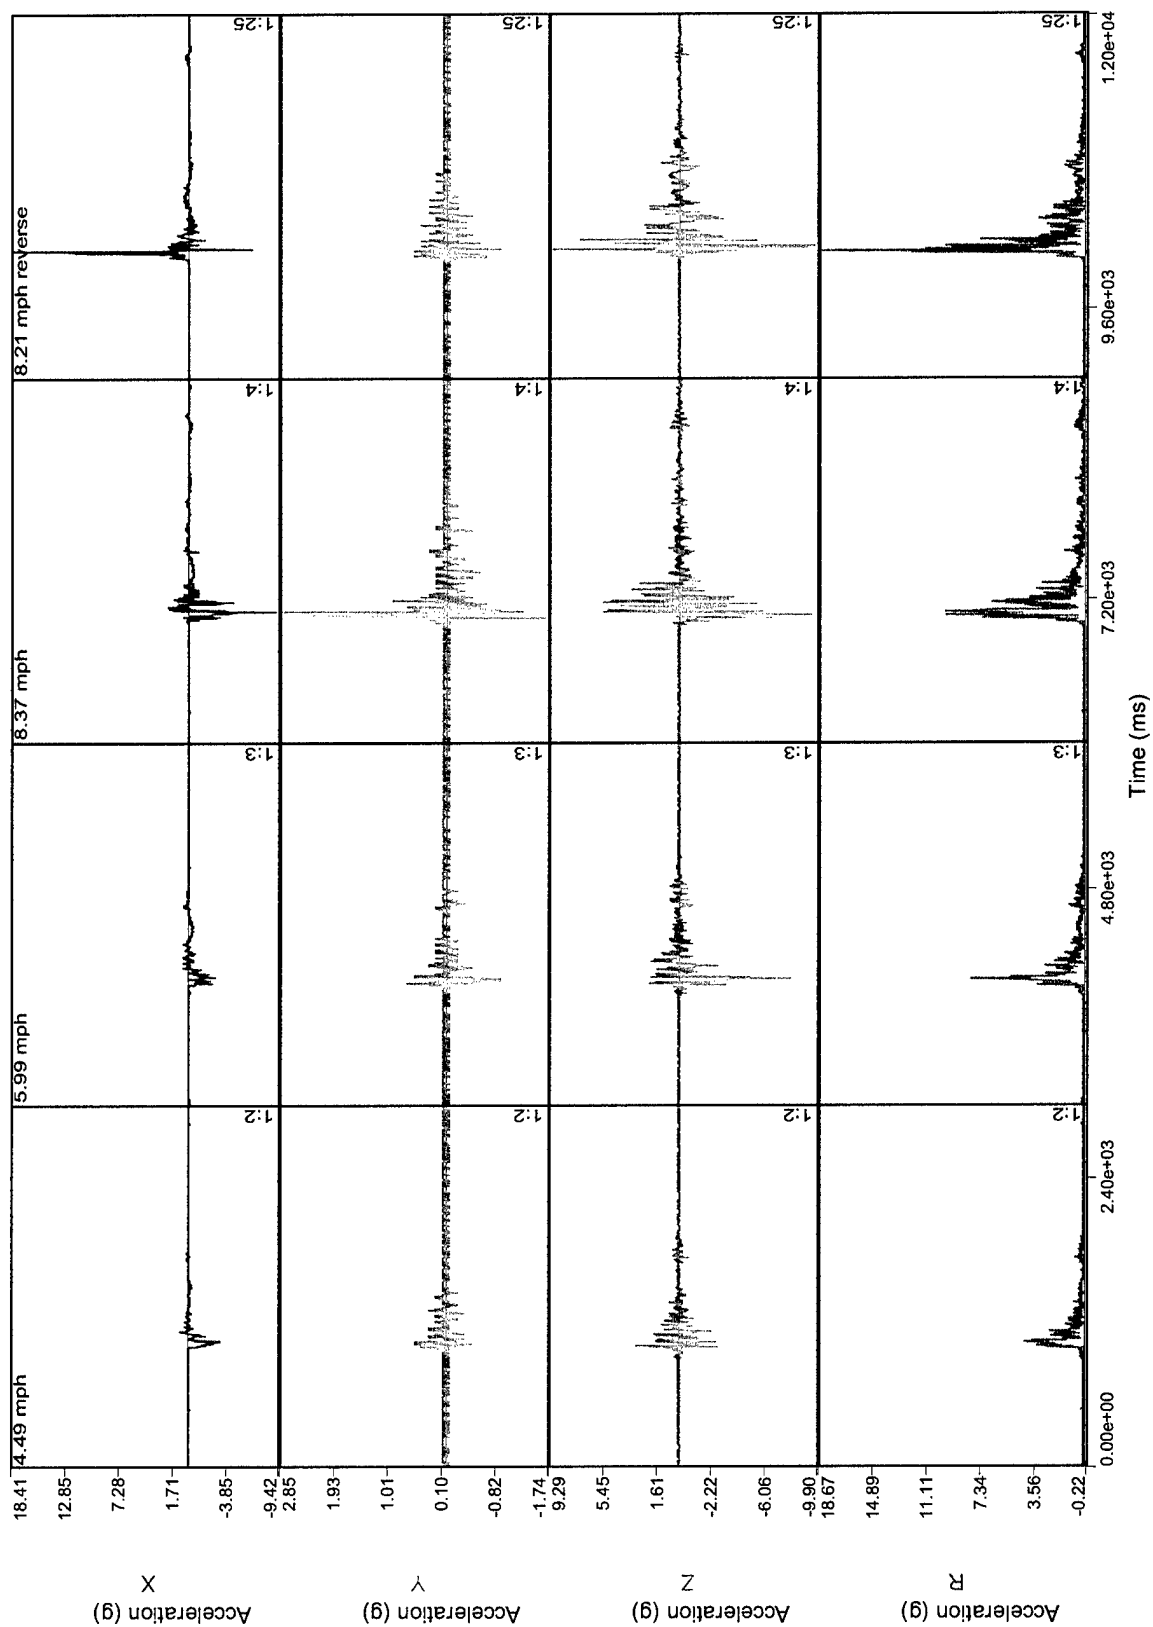
Rail Impact of M871A3 Trailer with 45,180-lb Payload - Sensor Location: Rear Railcar
